Re: Charlevoi Condominiums – East and West Building

Structural Integrity Reserve Study (SIRS)

150 Harborside Avenue Punta Gorda, Florida 33950

UES Project No: 0811.2300027.0000 – Task 6

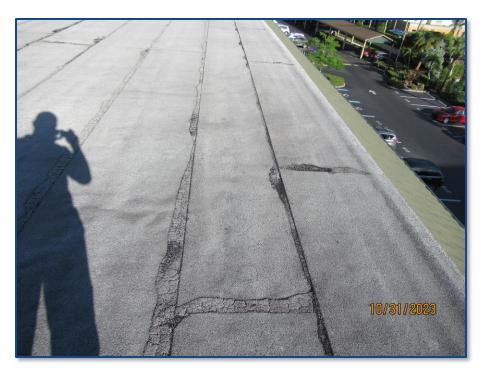
The roof system of the building is composed of a modified bitumen roof. At the time of inspection, deterioration in the roof membrane was observed throughout the roof system. Patch repairs were observed in multiple locations throughout the roof. UES was informed the roof was leaking but since has been addressed. At the time of inspection, the modified bitumen roof was observed to be in poor condition.

- Deterioration in the roof membrane was observed throughout the roof system. See Appendix C Photographs No. 15 through 17.
- Deterioration in the roof flashing sealant was observed in multiple locations. See **Appendix C** Photograph No. 18.

Photograph No. 15: View of deterioration in the roof membrane.

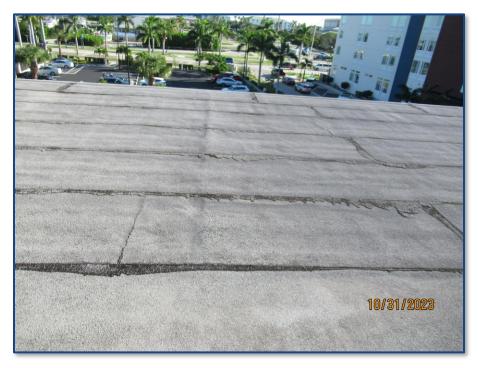
Photograph No. 16: View of deterioration in the roof membrane.

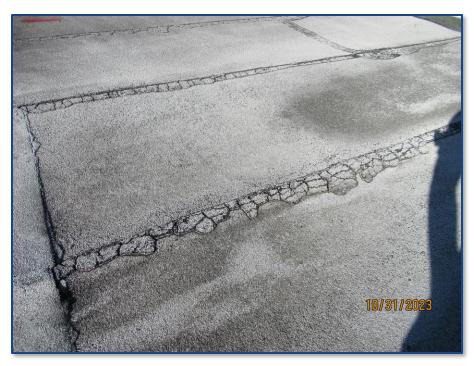
Photograph No. 17: View of deterioration in the roof membrane.

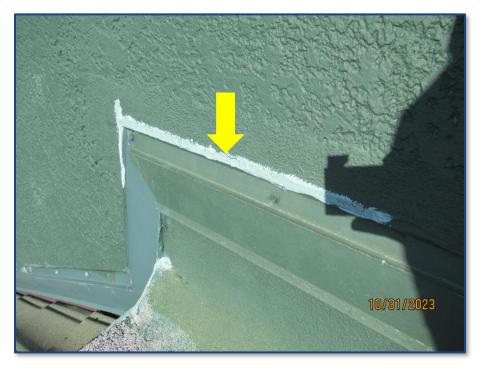
Photograph No. 18: View of deterioration in the roof flashing sealant.

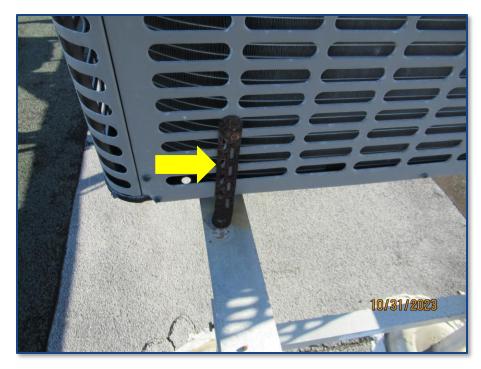
- Corroded and unattached condensing unit tie-down was observed. See **Appendix C** Photograph No. 19.
- Cracks were observed in the concrete masonry unit wall located in the workshop room. See **Appendix C** Photographs No. 20 through 22.

Photograph No. 19: View of corroded and unattached condensing unit tie-down.

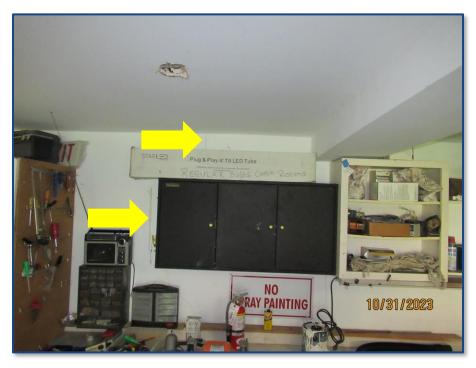
Photograph No. 20: View of cracks in the interior wall located in the workshop room.

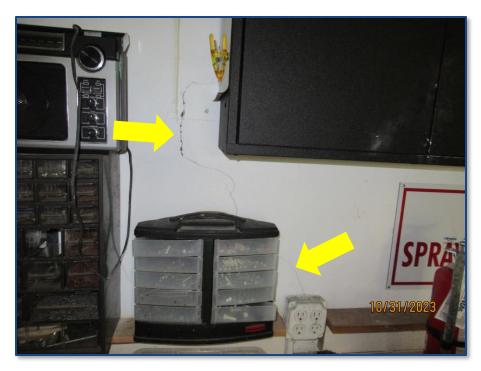
Photograph No. 21: Close-up view of Photograph No. 20.

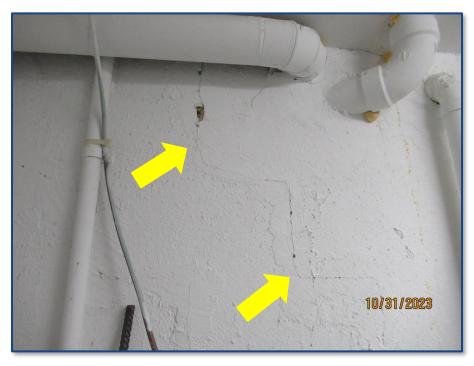
Photograph No. 22: View of stair-step crack in the interior wall located in the workshop room.

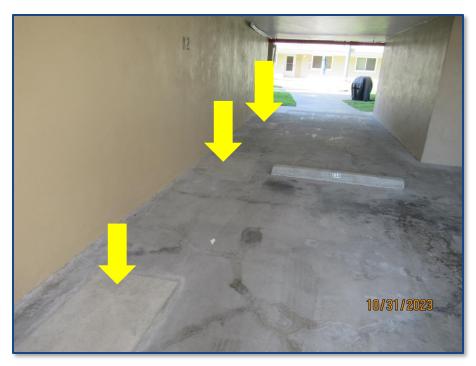
Photograph No. 23: View of previous concrete patch repairs located at the ground floor.

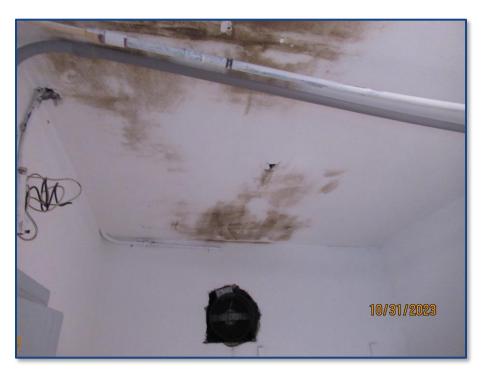
- Moisture damage in the interior ceiling finishes was observed in the pool equipment room and the exterior balcony of Unit 201. See **Appendix C** Photographs No. 24 and 27.

Photograph No. 24: View of moisture damage in the interior ceiling finishes located in the pool equipment room.

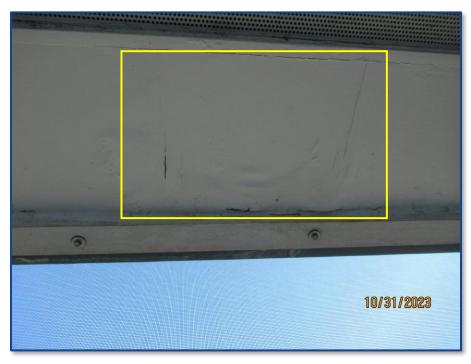
- Surface imperfections such as cracks, delamination, and bubbling of paint finishes were observed in ceiling and wall/column finishes. See **Appendix C** Photographs No. 26, 28 through 30, 35, and 36.

Photograph No. 26: View of cracks and bubbling of paint finishes in the ceiling finishes located in the balcony of Unit 301.

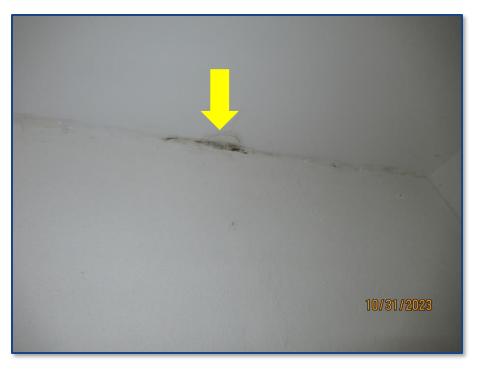
Photograph No. 27: View of moisture damage in the exterior balcony of Unit 201.

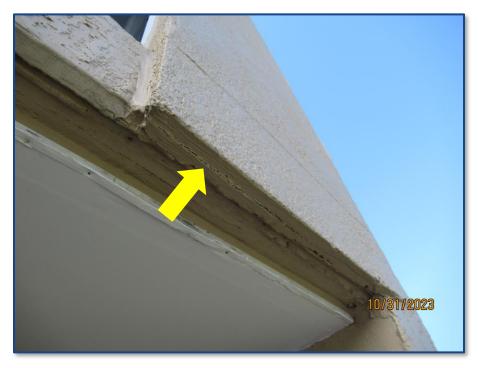
Photograph No. 28: View of crack in the exterior wall stucco finishes.

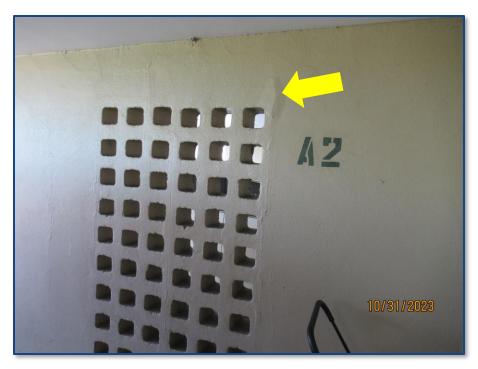
Photograph No. 29: View of bubbling in the exterior wall finishes located at the ground floor.

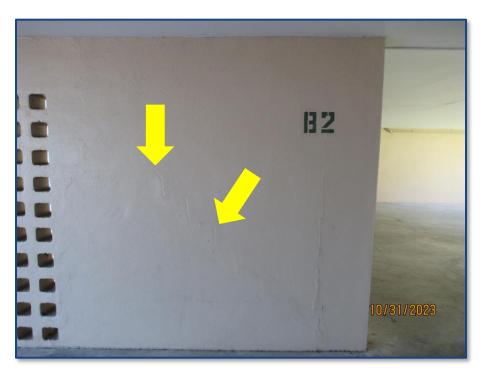
Photograph No. 30: View of previously repaired stair-step crack in the exterior wall finishes located at the ground floor.

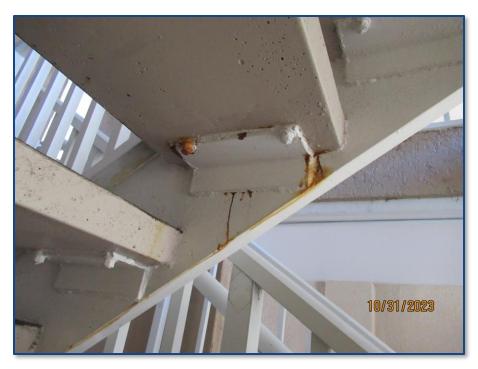
- Corroded steel angles, anchor, and deteriorated steel stringer were observed in the center stairway. See **Appendix C** Photographs No. 31 and 32.
- Cracks in the walkway coating finishes were observed in multiple locations. See **Appendix C** Photographs No. 33, 34, 37, and 38.

Photograph No. 31: View of corroded steel angle and anchor located at the center stairway.

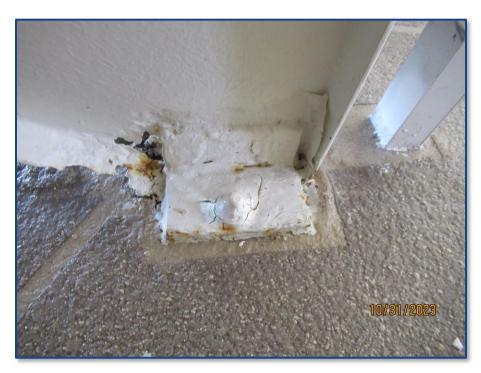
Photograph No. 32: View of corroded steel angle and deteriorated steel stringer located at the center stairway.

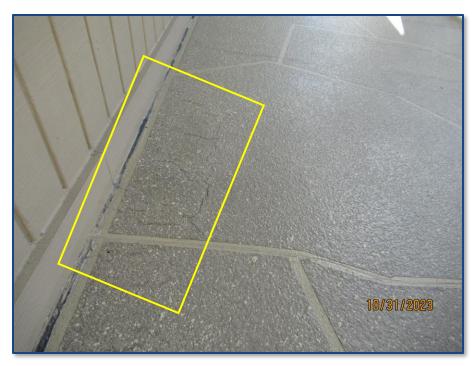
Photograph No. 33: View of cracks in the walkway coating finishes.

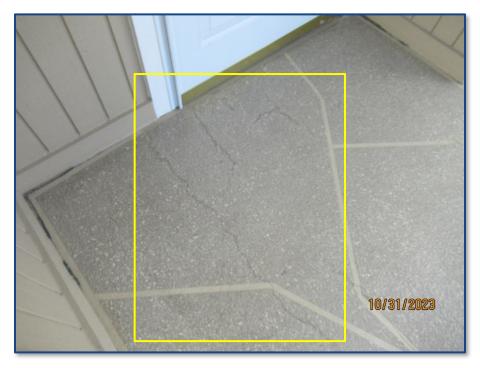
Photograph No. 34: View of cracks in the walkway coating finishes.

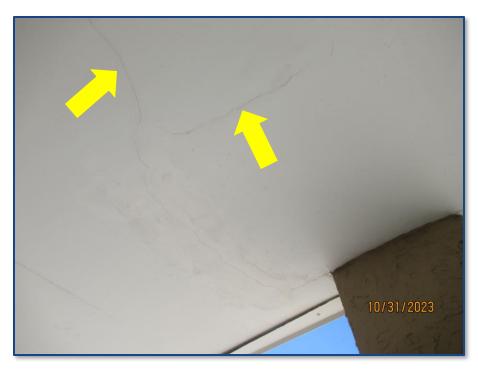
Photograph No. 35: View of cracks in the exterior walkway ceiling.

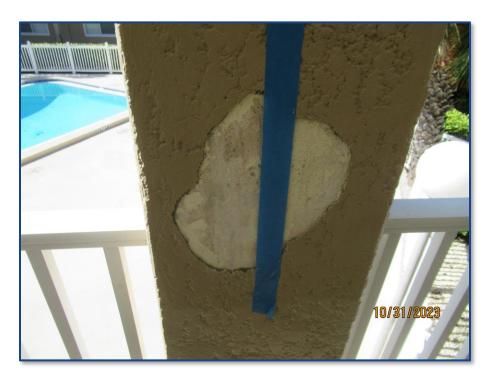
Photograph No. 36: View of delamination of the exterior stucco column finishes.

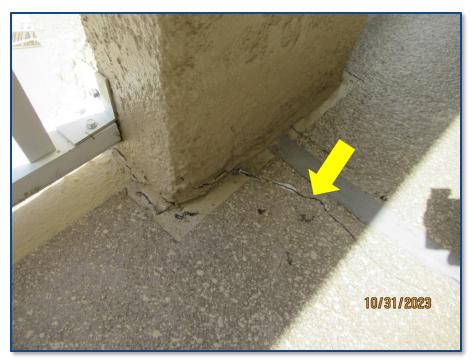
Photograph No. 37: View of crack in the walkway coating finishes.

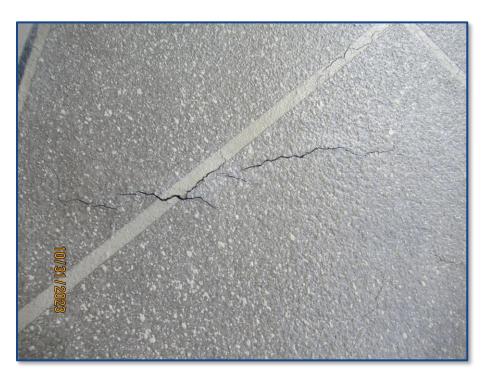
Photograph No. 38: View of cracks in the walkway coating finishes.

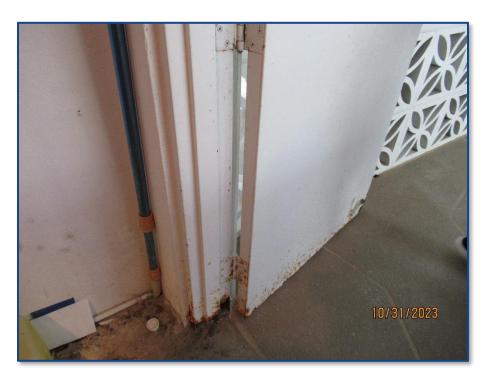
The building consists of 10 common windows and 14 common doors. The windows were observed to be in good condition. The doors were observed to be in good condition excluding the pool equipment door that was observed with corrosion in the door and door frame.

Photograph No. 50: Corrosion in the pool equipment common door.

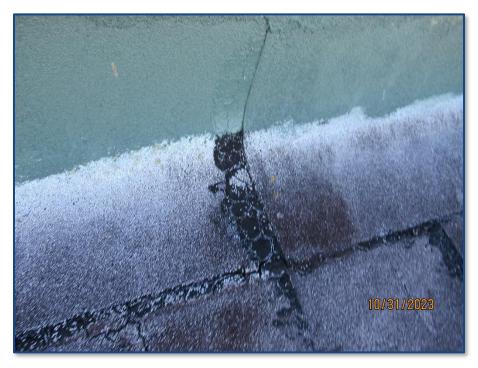
The roof system of the building is composed of a modified bitumen roof. At the time of inspection, deterioration in the roof membrane was observed throughout the roof system. Patch repairs were observed in multiple locations throughout the roof. UES was informed the roof was leaking but since has been addressed. At the time of inspection, the modified bitumen roof was observed to be in poor condition.

- Deterioration in the roof membrane was observed throughout the roof system. See Appendix C Photographs No. 12, 13, and 15.
- Surface imperfections such as cracks, bulging, and exposed metal lath were observed in the walkway ceiling finishes, concrete column finishes, and in the elevator machine room. See Appendix C Photographs No. 20, 24 and 26.
- Corroded steel angles were observed in the center stairway. See **Appendix C** Photographs No. 22 and 23.
- Cracks in the walkway coating finishes were observed in multiple locations. See **Appendix C** Photograph No. 25.
- Damage to the door opening frame observed at the trash room. See **Appendix C** Photographs No. 36 and 37.

Photograph No. 12: View of deterioration in the roof membrane.

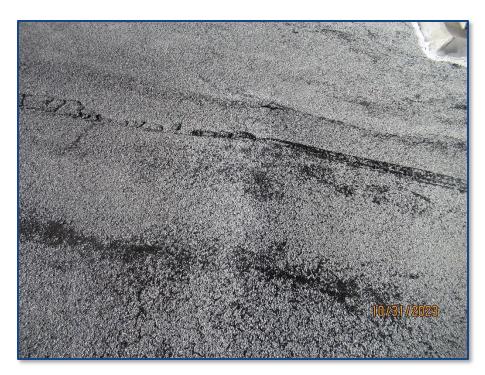
Photograph No. 13: View of deterioration in the roof membrane.

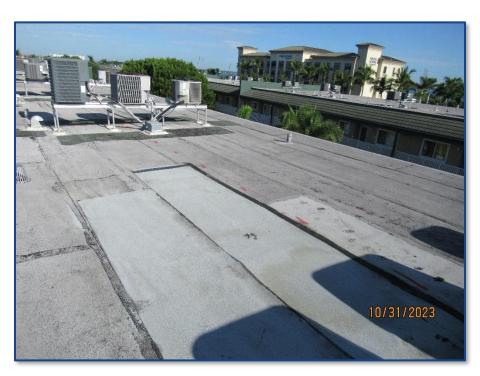
Photograph No. 14: View of previous roof patch repairs.

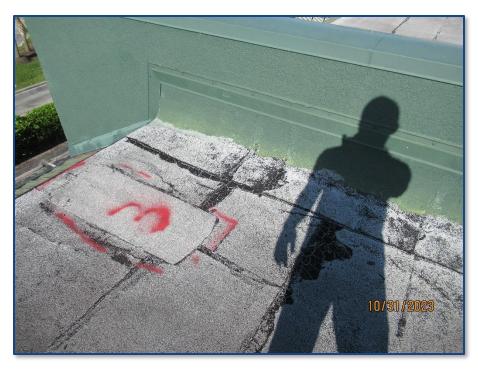
Photograph No. 15: View of deterioration in the roof membrane and previous roof patch repair.

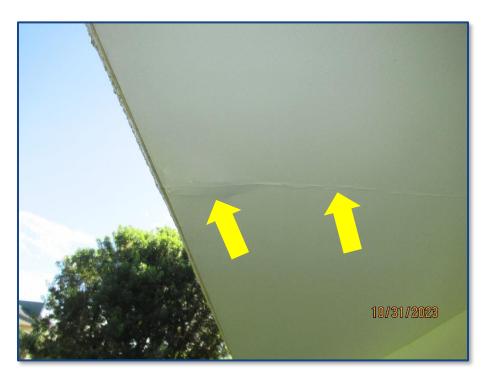
Photograph No. 20: View of cracks and bulging of the exterior walkway ceiling finishes.

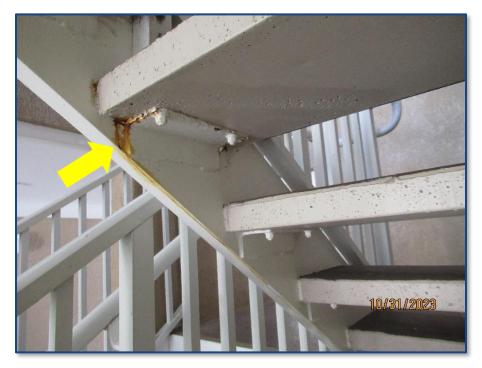
Photograph No. 22: View of corroded steel angle located in the middle exterior stairs.

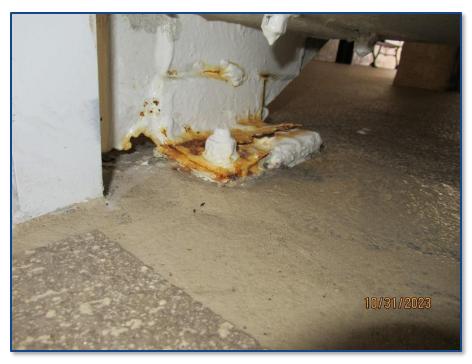
Photograph No. 23: View of significantly corroded steel framing base anlge.

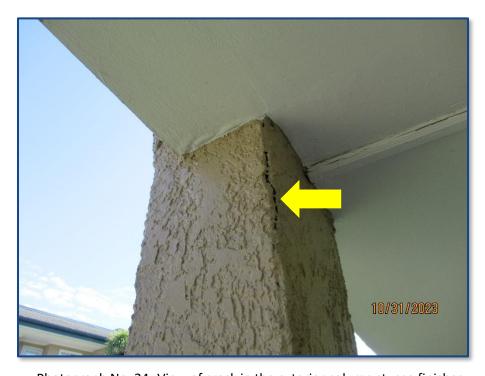
Photograph No. 24: View of crack in the exterior column stucco finishes.

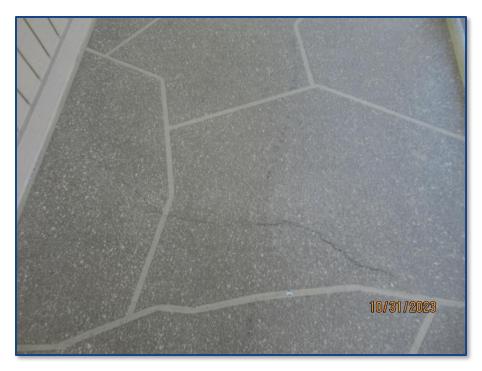
Photograph No. 25: View of cracks in the walkway coating finishes.

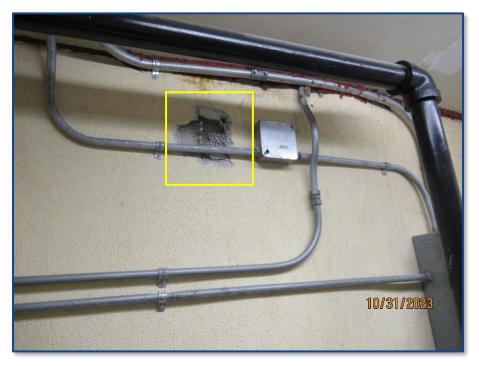
Photograph No. 26: View of exposed metal lath in the interior wall finishes located in the elevator machine room.

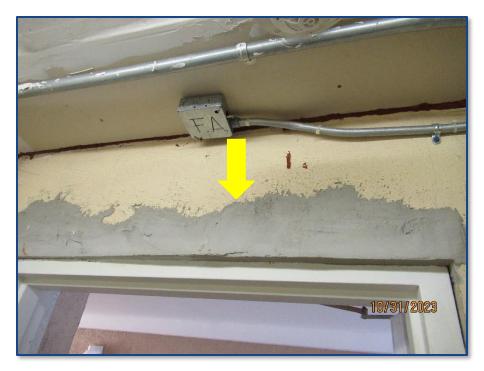
Photograph No. 27: View of previous patch repair above door opening located in the elevator machine room.

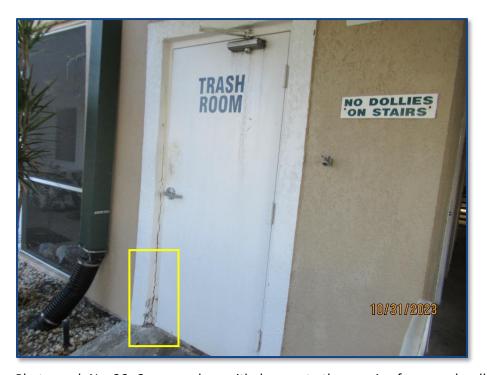
Photograph No. 36: Common door with damage to the opening frame and wall finishes.

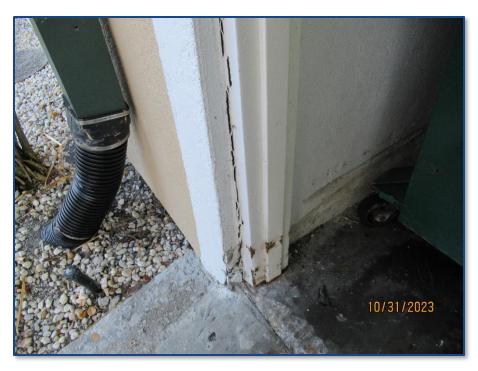
Photograph No. 37: Close-up view of Photograph No. 36.
