Re: Charlevoi Condominiums – East and West Building

Structural Integrity Reserve Study (SIRS)

150 Harborside Avenue Punta Gorda, Florida 33950

UES Project No: 0811.2300027.0000 – Task 6

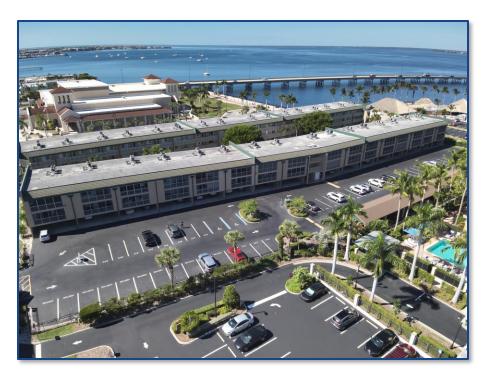
Photograph No. 1: View of the east (front) elevation of the building.

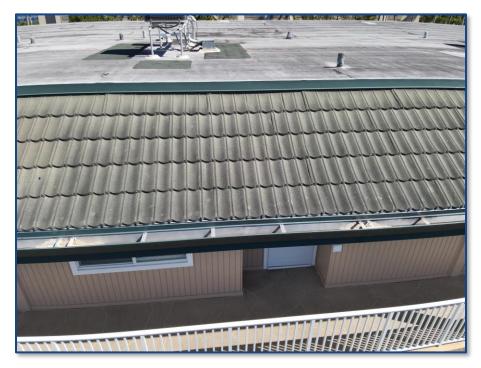
Photograph No. 12: Partial view of the mansard metal roof panels.

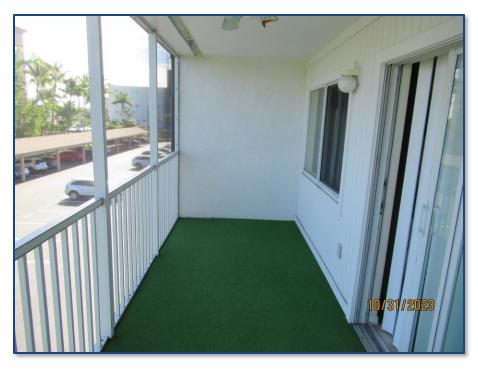
Photograph No. 25: General view of the exterior balcony of Unit 301.

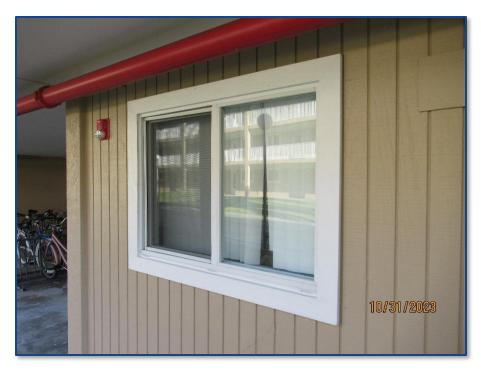
10 common windows exist all on the East Building. The age of the windows is unknown. Existing common window appeared in good condition so the lifespan was estimated to extend an additional 15 years.

Photograph No. 49: Common window.

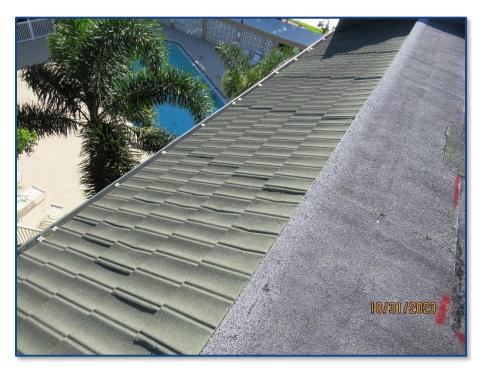
Photograph No. 16: Partial view of the mansard metal roof panels.

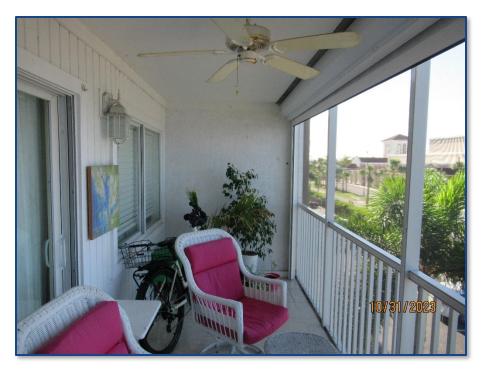
Photograph No. 17: General view of the balcony of Unit 321.

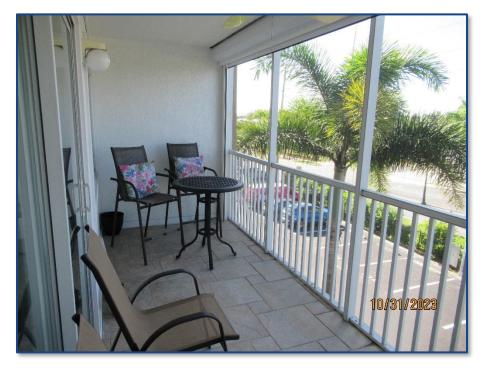
Photograph No. 18: General view of the balcony of Unit 333.

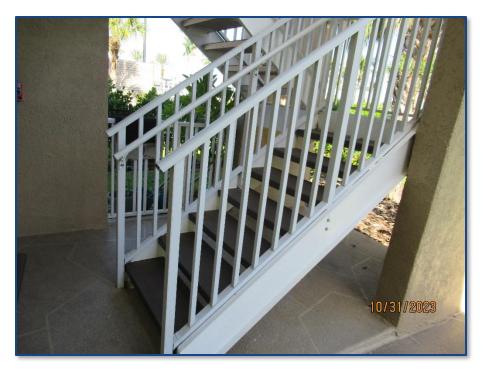
Photograph No. 19: General view of the exterior stairs.

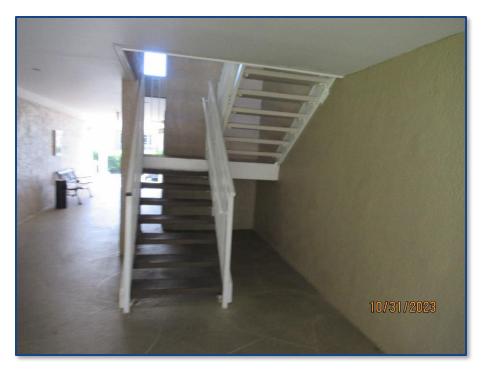
Photograph No. 21: General view of the middle exterior stairs.

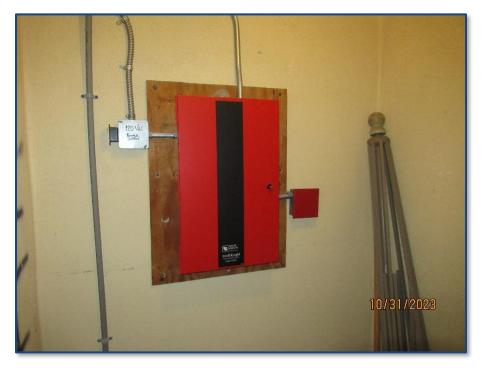
Photograph No. 28: Fire alarm panel.

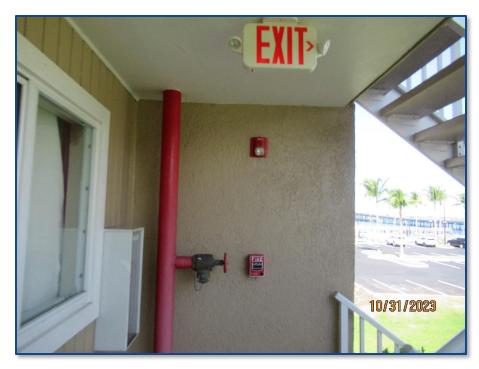
Photograph No. 29: Fire protection plumbing system, emergency exit sign, and fire alarm pull station.

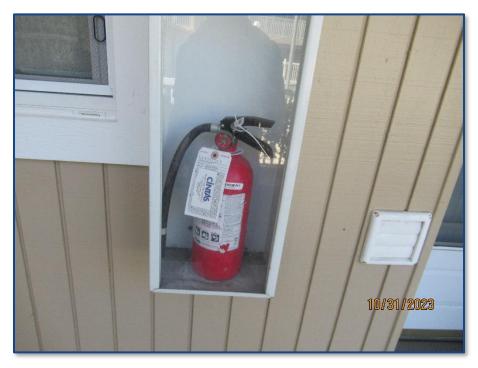
Photograph No. 30: Fire extinguisher.

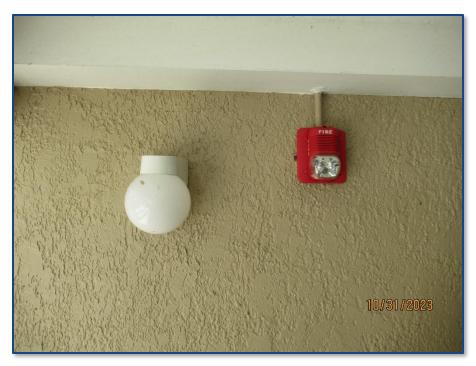
Photograph No. 31: Fire alarm system sensor.

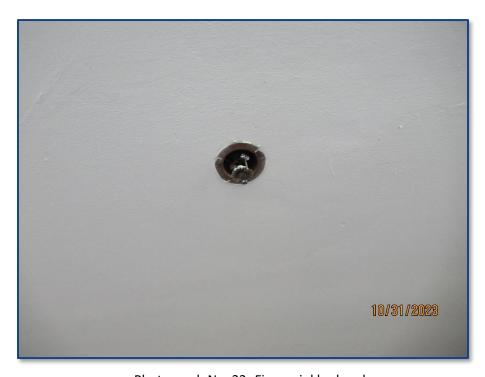
Photograph No. 32: Fire sprinkler head.

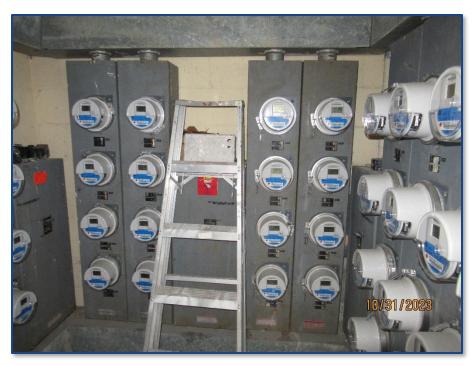
Photograph No. 33: Electrical meters.

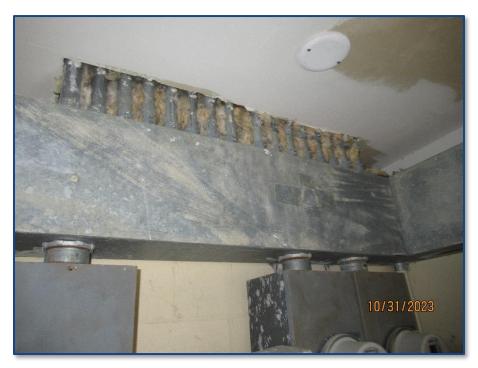
Photograph No. 34: Electrical conduits.

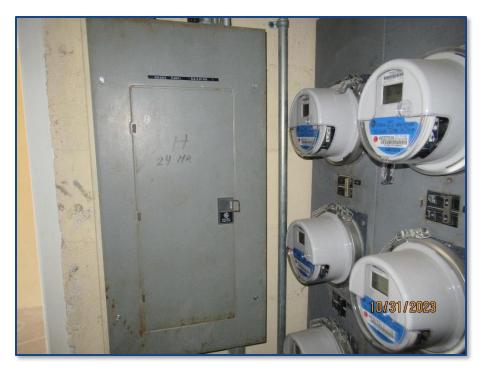
Photograph No. 35: Electrical panel.

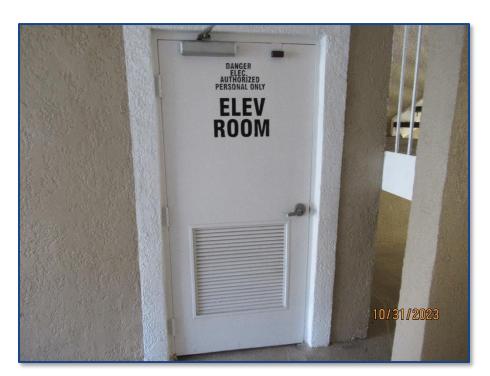
Photograph No. 38: Common door.
